# STATION 5

## Morrison Road Bridge over the Contoocook River

Option B—Identified by Hoyle, Tanner & Associates, Inc.

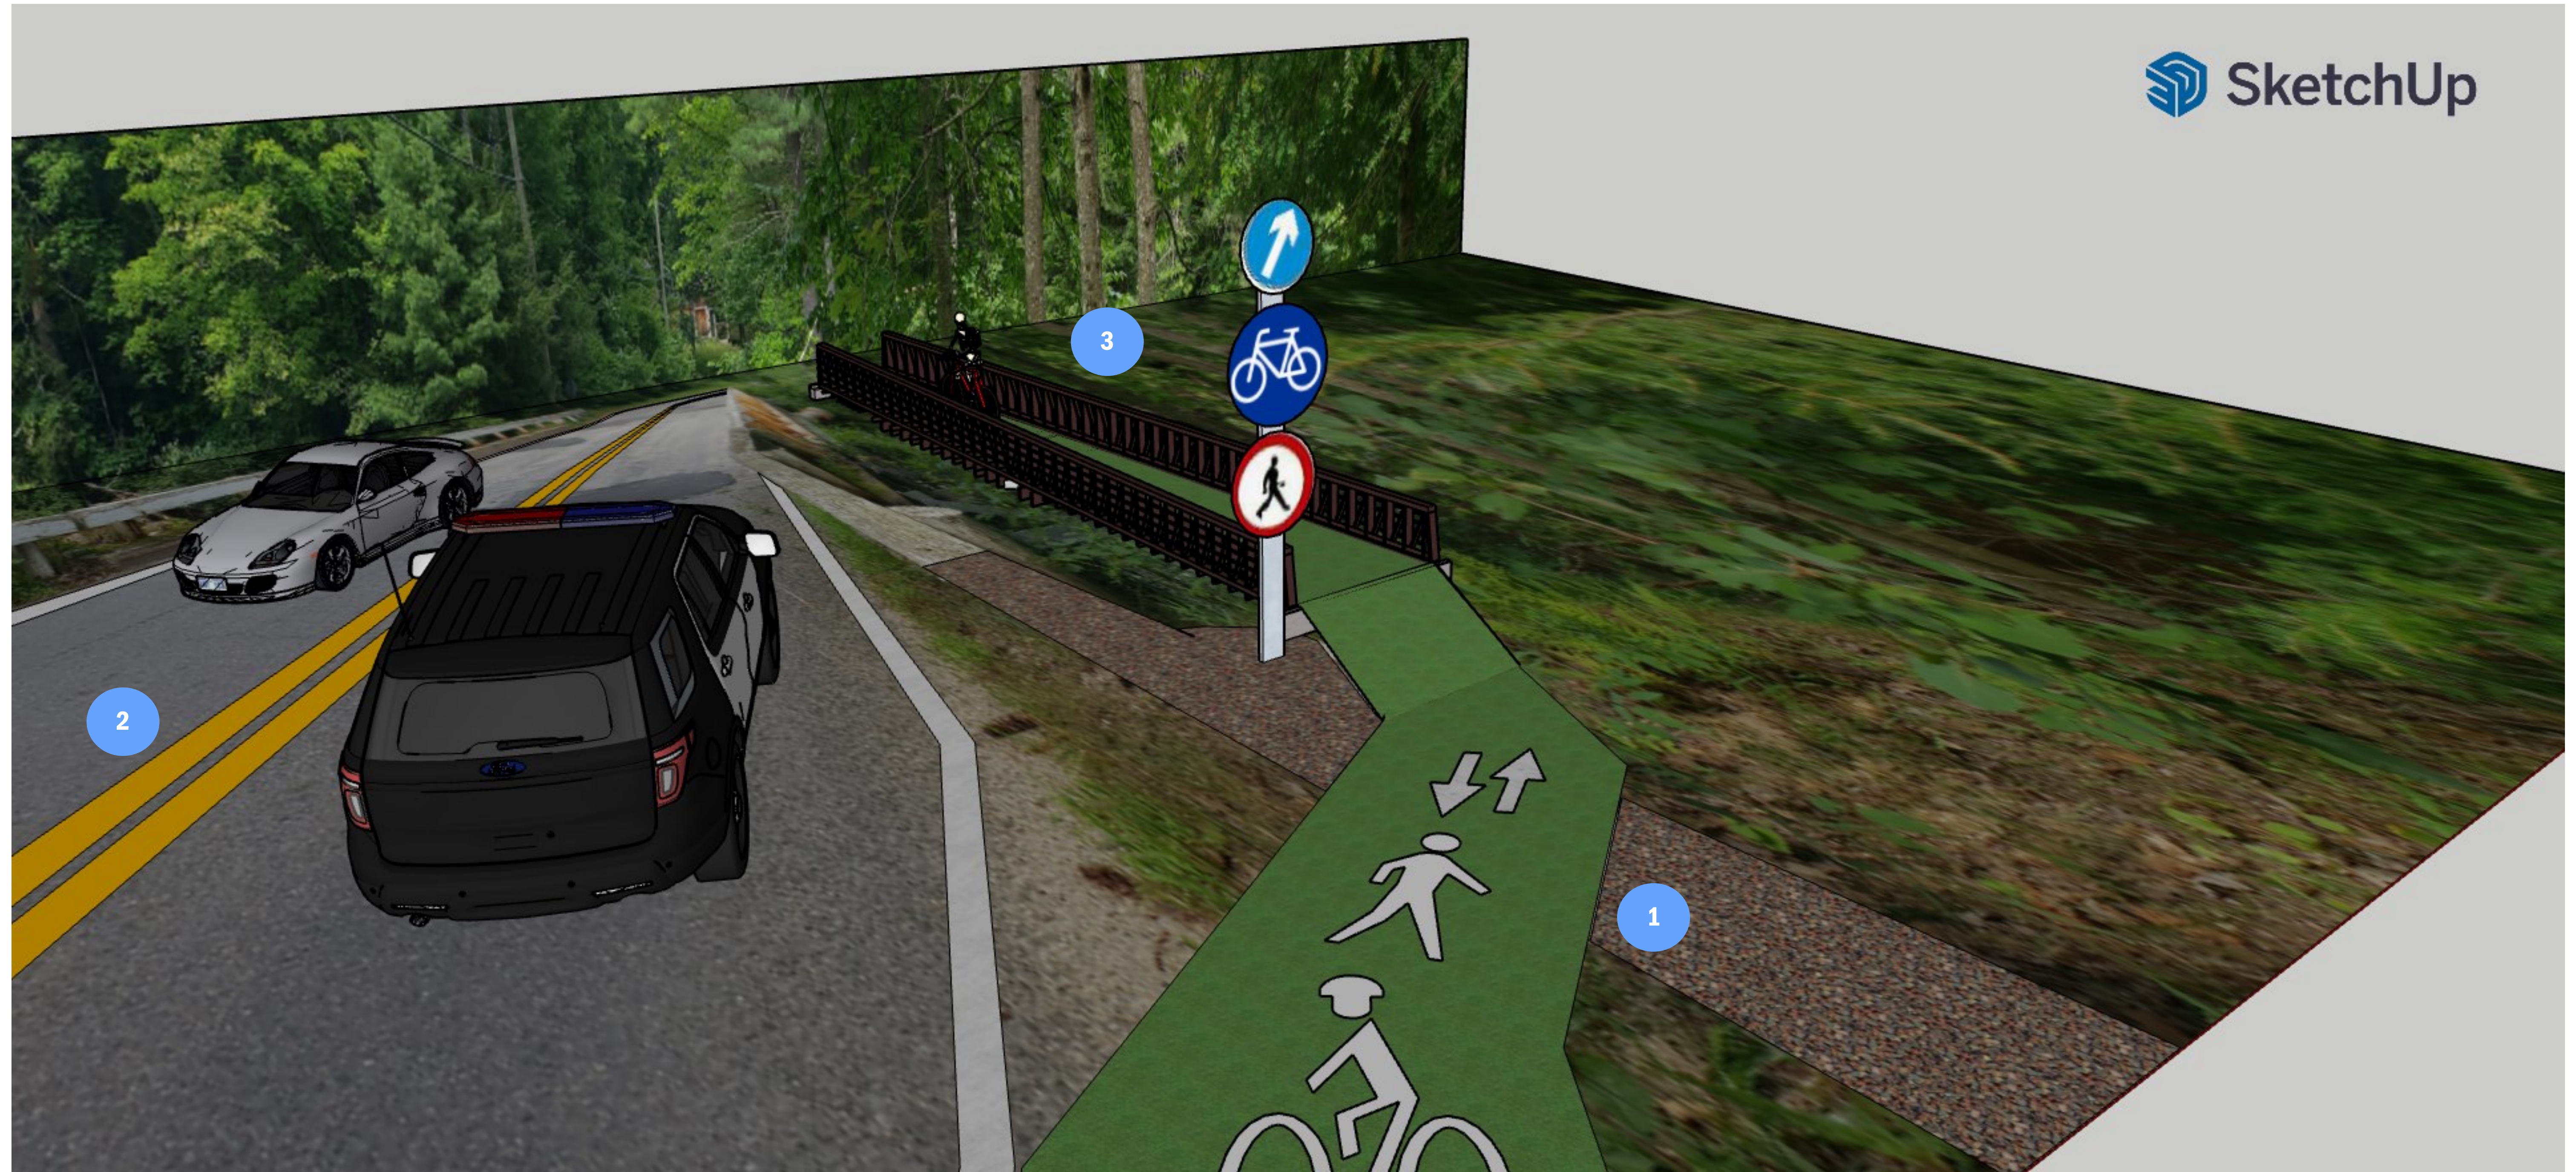
### DETAILS

- 1) Advisory shoulder for cyclists and pedestrians, to be directed over a foot-bridge
- A true, protected bike lane is not possible due to the limited width of roadway
  - Full sidewalk is not possible due to expensive cost to install and maintain

2) Pavement markings

- 3) Foot bridge added for pedestrian and cyclists to cross over river. Bridge deck widened enough for two-lane car travel but not enough for an advisory shoulder.
