STATION 2

Powersbridge Road Culvert

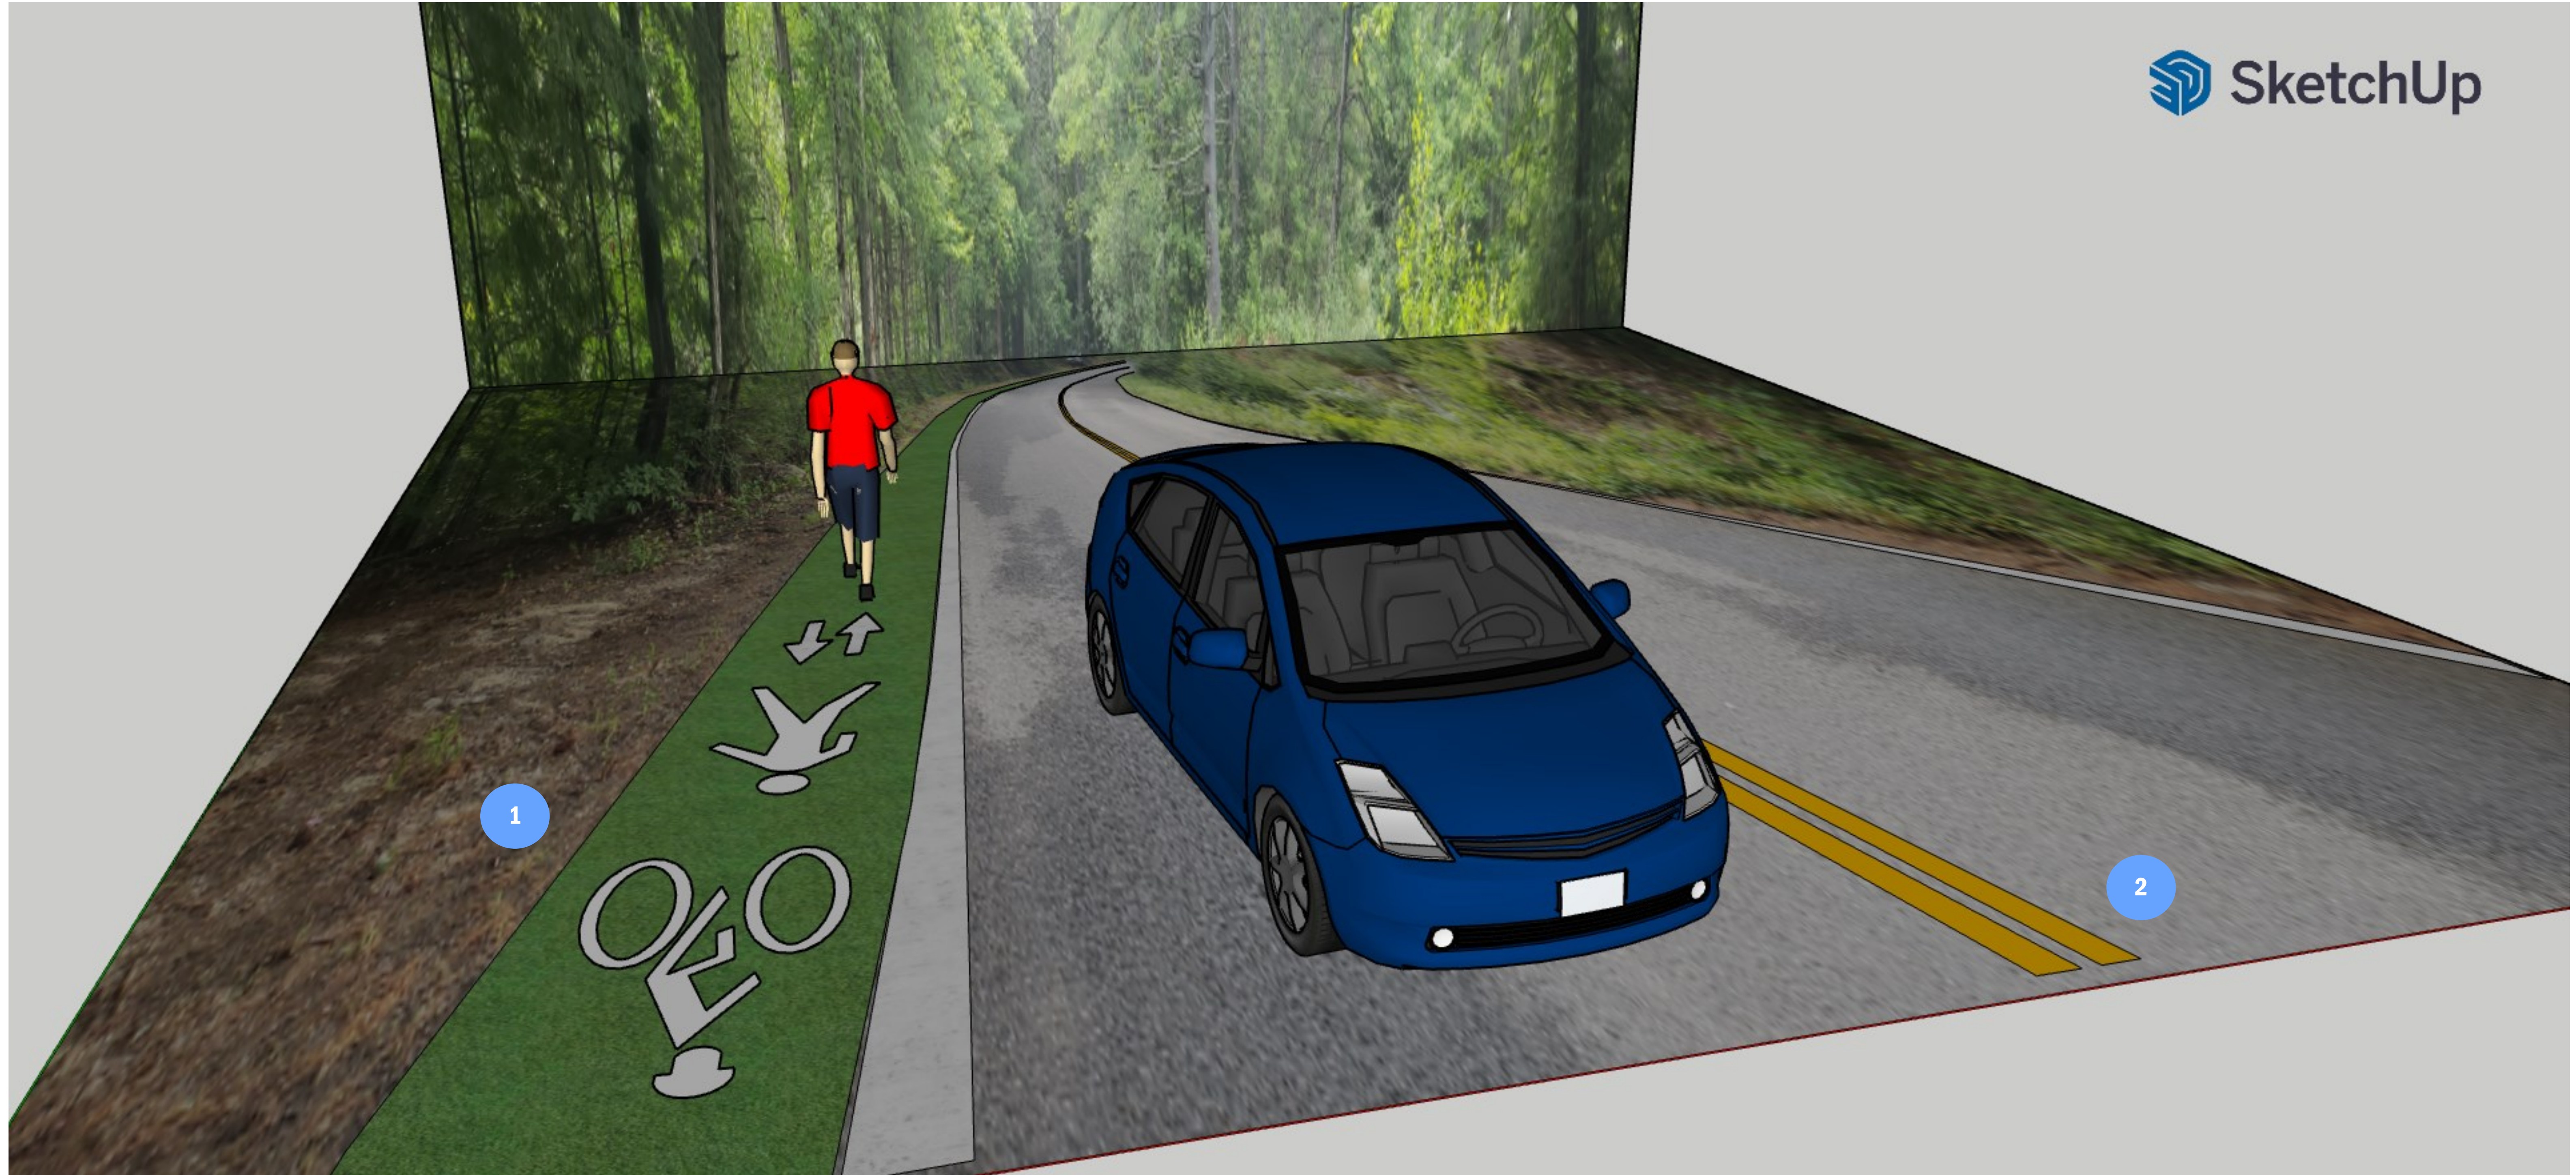
DETAILS

1) Advisory shoulder for cyclists and pedestrians

- A true, protected bike lane is not possible due to the limited width of roadway
- Full sidewalk is not possible due to expensive cost to install and maintain

2) Pavement markings
