STATION 6

Grove Street Extension

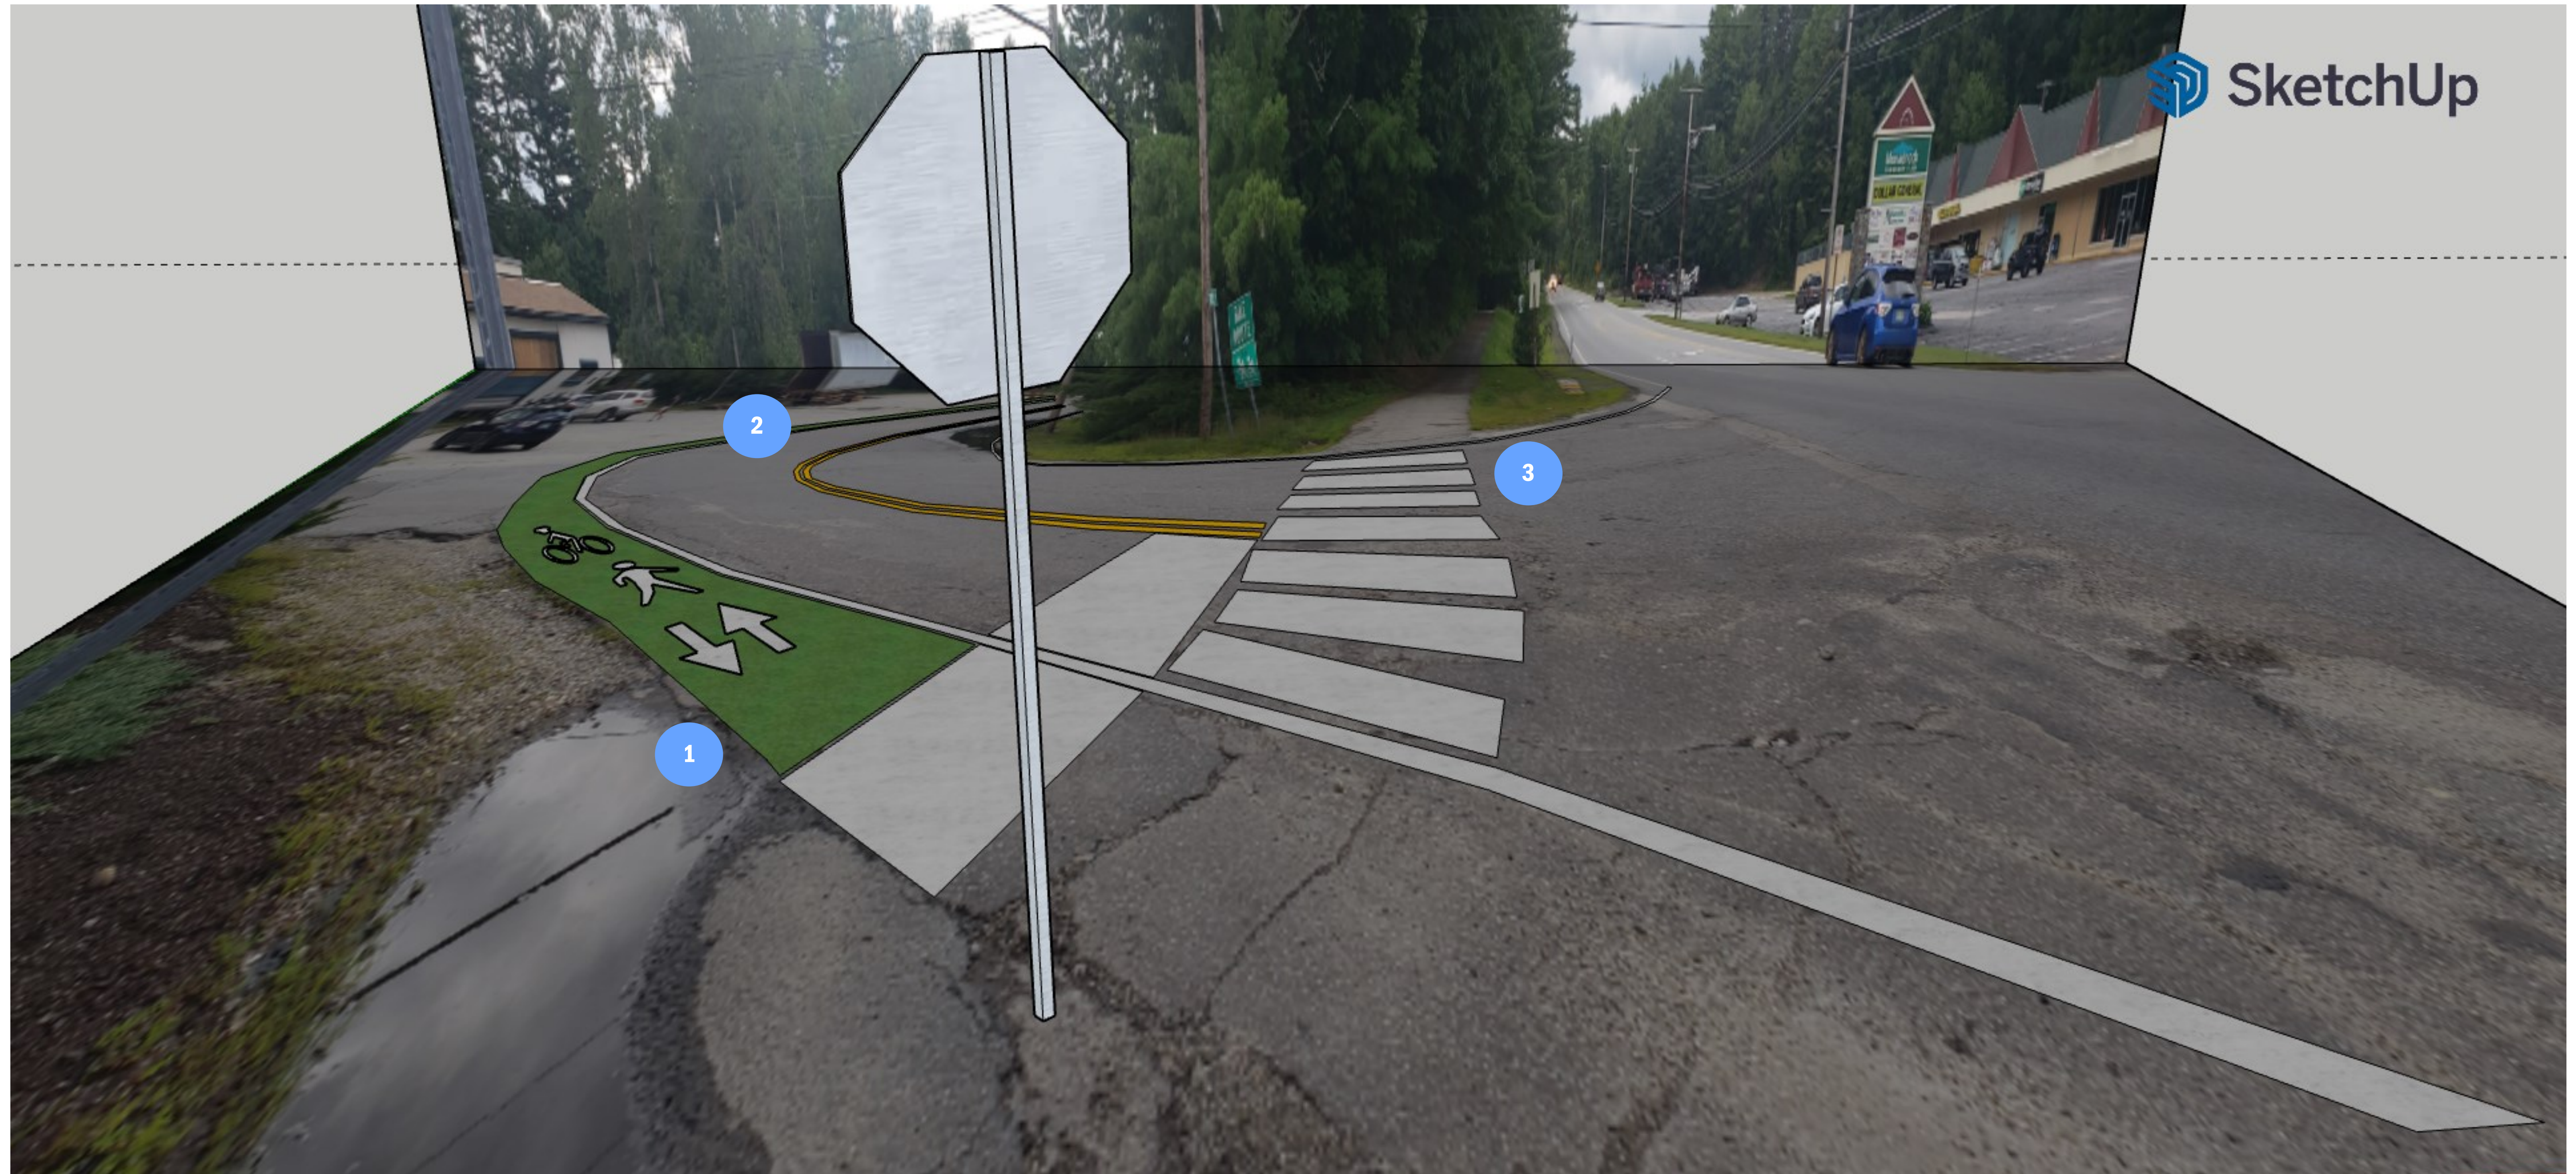
DETAILS

1) Advisory shoulder for cyclists and pedestrians

- A true, protected bike lane is not possible due to the limited width of roadway
- Full sidewalk is not possible due to expensive cost to install and maintain

2) Pavement markings

3) Crosswalk connection to Common Pathway
